SWINDON ENGINEERING SOCIETY.

**TRANSACTIONS, 1906-7**

“ LOCOMOTIVE CRANKS AND AXLES,”

RODON. L. BURGE (MEMBER).

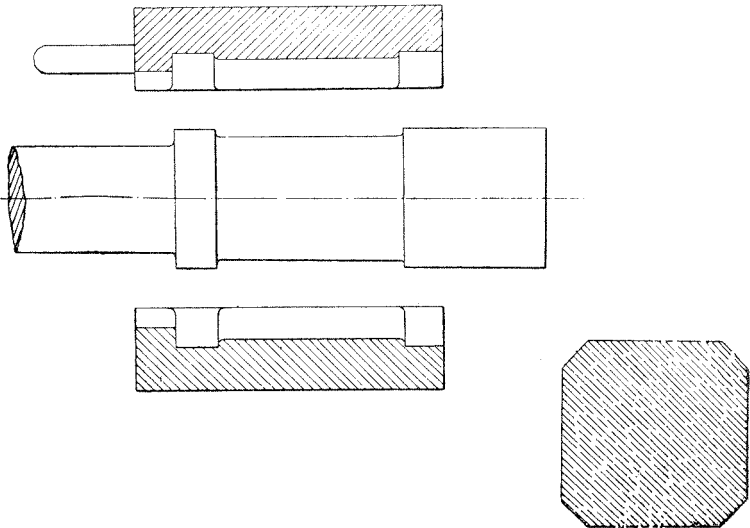
Fig. 3.

MANUFACTURE OF STRAIGHT AXLES.— Straight axles are usually made from blooms about 5' 0" long, 10" square, with round corners, one end rounded to about  $9\frac{1}{2}$ " in diameter and cut off in swages, the neck and collar are then stamped in a pair of swages, as shown in Fig. 3, the middle being hammered down, leaving about  $\frac{1}{4}$ " for turning. In some works the blooms are rolled to the rough section in a cogging mill. In all cases the axles are worked at two heats, one half of each axle being finished before the other is commenced, either by swages or fast hammer blocks.

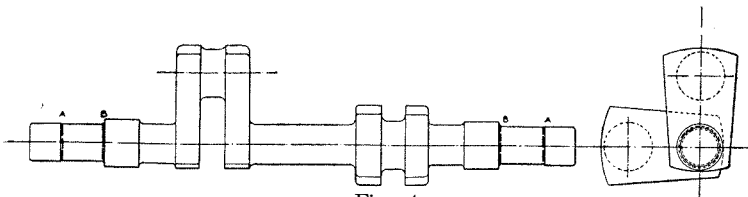
Fig. 4.

G.W.R. crank axles with taper webs (Fig. 4) have attained long lives and high mileage. These cranks, which were of iron, had small journals, and seldom fractured ; some are in use at the present day. This type of crank axle was also used on early Metropolitan engines with the addition of hoops (see Fig. 5). They were found to fracture chiefly in the inside journal, close to crank web.

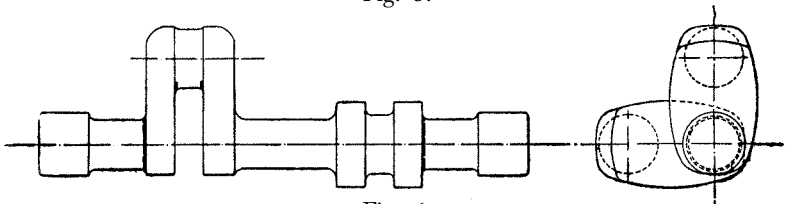
Fig. 6.

Fish-bellied webs, such as used on the G.W.R. standard single-framed goods engines Nos. 2301-2500, fracture chiefly in the inside journal,

and occasionally circumferentially. (See Fig. 6.) These are very good cranks and do a good mileage. The same type of crank, is, with hooped webs, used on G.W.R. engines Nos. 1660-1700 (Fig. 7).

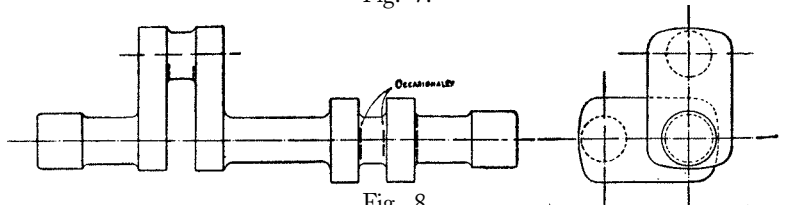
Fig. 8.

The journals wear small and taper, probably due to underhung springs. The hoops are left off to clear the pump. Fig. 8 illustrates a crank with straight webs, which is used on the G.W.R. Wolverhampton  $\frac{0.4.2.}{T}$  class engines.

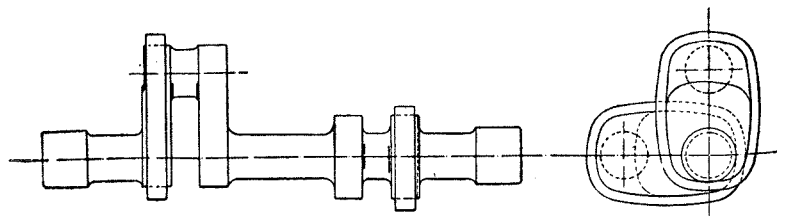
Fig. 9.— G.W.R.  $\frac{0.6.0.}{T}$  and  $\frac{2.4.0.}{T}$

NOTE.— Thick lines indicate where fractures usually occur.

Some of the early Metropolitan engines were fitted with cranks having fish-bellied webs, but hooped on outside webs only (Fig. 9). The crank shown in Fig. 10 has elliptical webs which are hooped. Fractures chiefly occur in journals close to the webs.

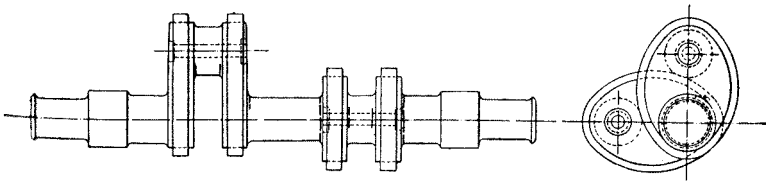
Fig. 12.

G.W.R. engines No. 3001-3080 are fitted with elliptically-webbed cranks (Fig. 12). These often break in the body, and sometimes fracture in the pins and inside journals.

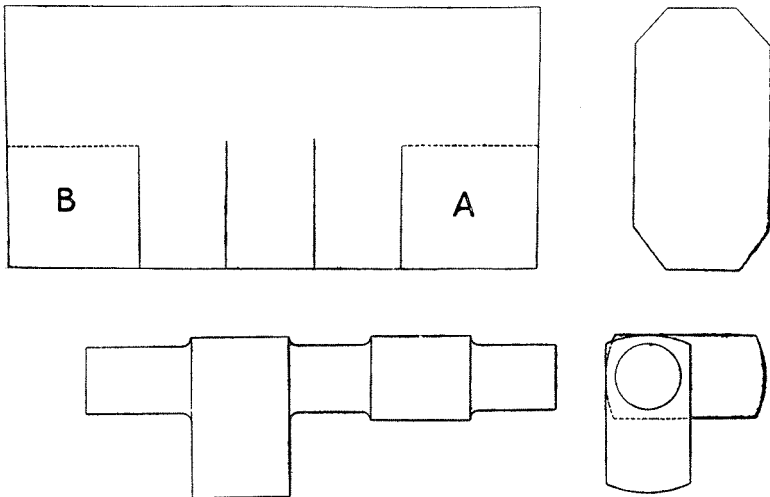
Fig. 14.

The ingot is drawn down to a slab (see Fig. 14), and brought to the hot saw and sawn for the webs. The gusset A is then cut out with a large cutter and the end roughly rounded. The portion between the webs is then removed by cutters, the staff changed, reheated, and the gusset B cut out and the end rounded. The hammer blocks are then changed for a smaller set, so that the middle can be rounded and then reheated for twisting (right hand web to lead in most cases). The second web is then placed between the anvil and tup, and the leading web has a large spanner attached, by which it is drawn up at

right angles. The middle is then hammered to its finished forge size, as are also the ends. The webs are next rounded under the hammer, top and bottom, and if found to be of slightly insufficient width, a fuller, consisting of a round bar, is stamped down the centre, which widens them out without affecting the thickness where it is required.

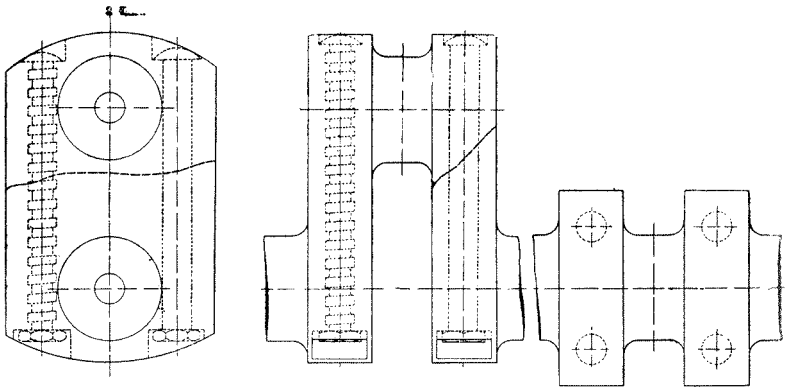
Fig. 14.

Fig. 15 illustrates a crank designed and patented by Mr. C. E. Stretton to overcome these difficulties. The crank is manufactured in the usual way, and the improvement for strengthening the webs consists in drilling two holes about 2" diameter through the length of the webs. A bolt, pin, or screw is then passed through each hole. The bolt should be made of steel, having a tensile strength of 40 tons per square inch, and can be either screwed into the web or made a driving fit and forced in by hydraulic pressure and afterwards secured by a nut and split pin.

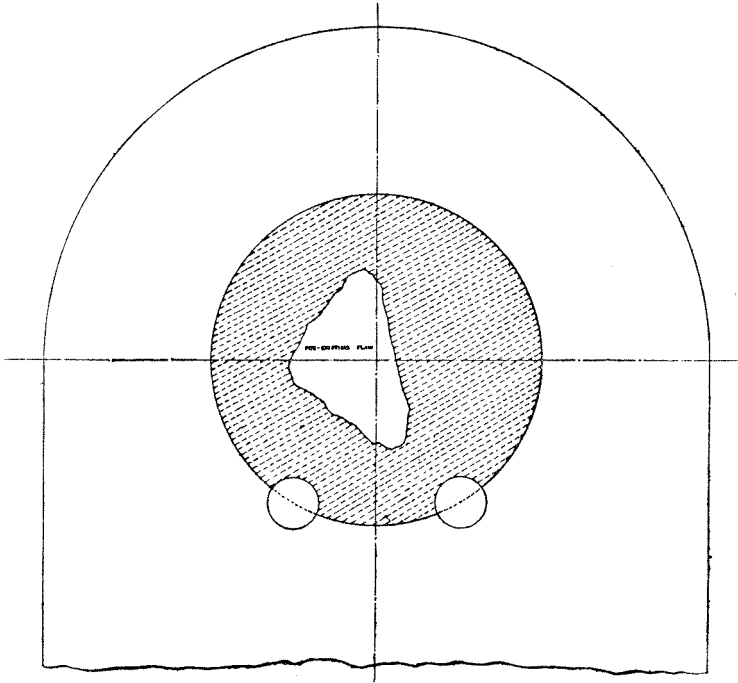
Fig. 17.

Built-up crank axles for locomotives (Figs. 16 & 17) are not altogether uncommon, and the method of building may be briefly described as

follows :—The webs are first planed and bored out to gauge to receive the body and crank pins, the body being turned slightly larger in diameter than the holes in the web. The webs are expanded, usually in a gas furnace, to receive the body and pins, and after fixing are partly cooled by compressed air and finally cooled in water. Holes, about  $1\frac{1}{4}$  inches diameter, are drilled, half in the pin and half in the web. These are tapped and screws inserted to ensure the pins from revolving. When the whole crank is built up, the ends, body and journals are turned and keyways cut. The crank is then ready to be pressed into the wheels. An advantage possessed by built-up cranks is that they are capable of being repaired ; the initial cost is also less. They are heavier, stronger and more reliable than solid cranks and show a better mileage.

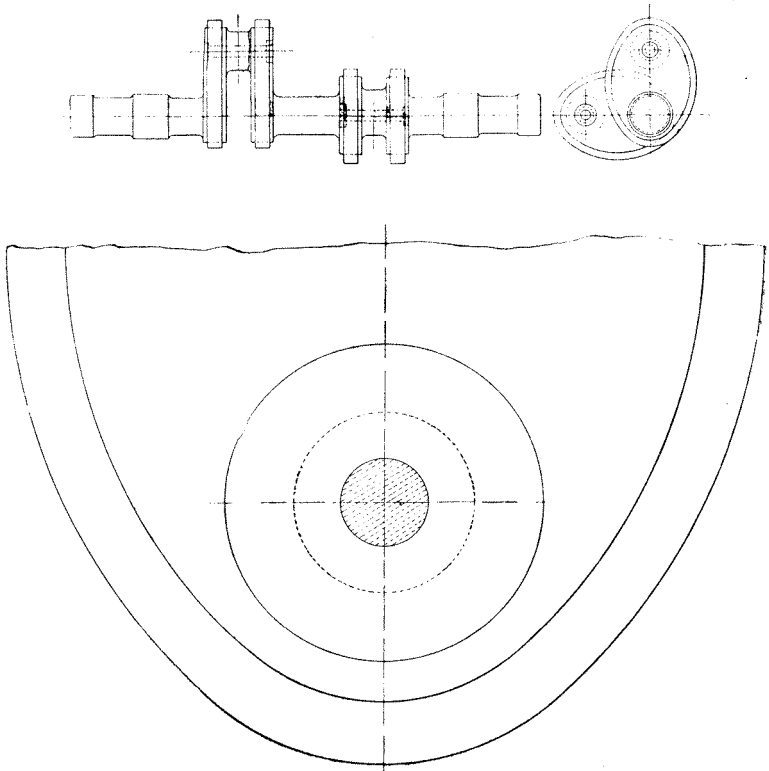
Fig. 18.

Figs. 18 to 22 will show where fractures usually occur in different types of crank axles.

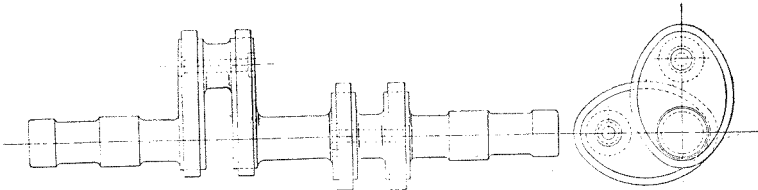
Fig. 20.— G.W.R. 4.4.0. and 2.6.0. class.

NOTE:— Thick lines indicate where fractures usually occur.
